Ice breakup on the Chena River
1975 and 1976

CRREL Report 77-14

Terry T. McFadden and Charles M. Collins

U.S. ARMY ENGINEER DISTRICT, ALASKA

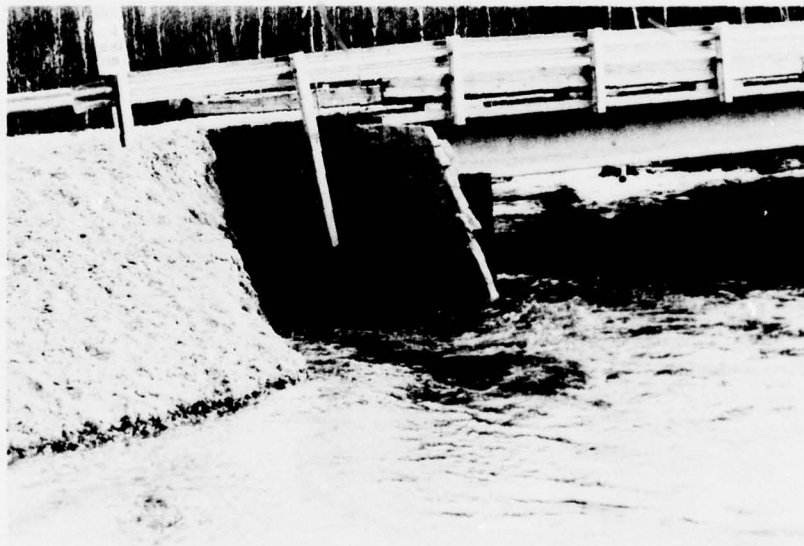
A sizeable effort was expended at the bridge to remove logs from in front of its pilings. The south approach eroded 5 m back from the bridge, although the

Figure 3. Early stages of damsite bridge approach washout (12 May 1975).

bridge remained with no apparent damage when the high water subsided. Debris accumulation was also a problem at Engineer Bridge on Fort Wainwright. However, the trash racks in front of this bridge protected the bridge pilings. Figures 4 and 5 show the debris accumulation at the two bridges and the advantages of the trash tracks.

isolated, and the approaches to the bridge at the flood control damsite were washed out. A large amount of debris was carried downstream which contributed heavily to the washout problem at the bridge. This emphasized the need for adequate debris handling equipment at the damsite during the breakup or other high water periods. Equipment recommendations were outlined in the 1974 breakup report (McFadden and Stallion 1975).

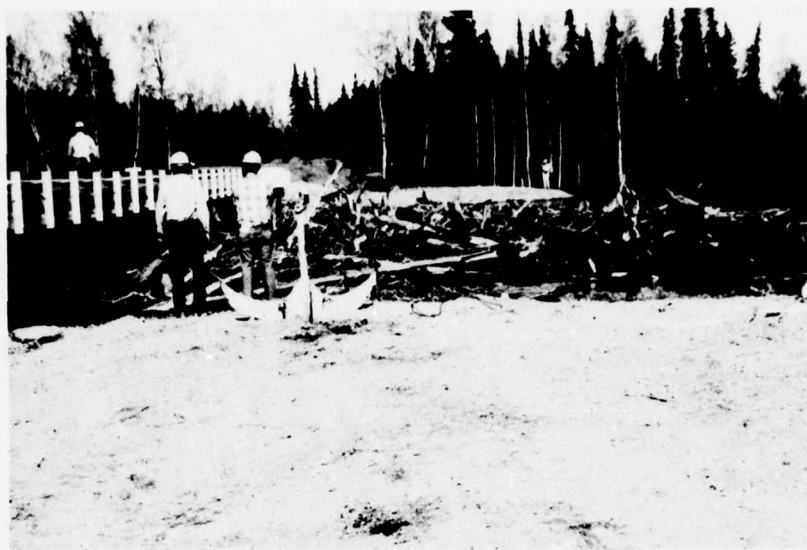
Figure 4. Debris accumulation behind bridge at damsite (12 May 1975). Note trash hook in foreground.

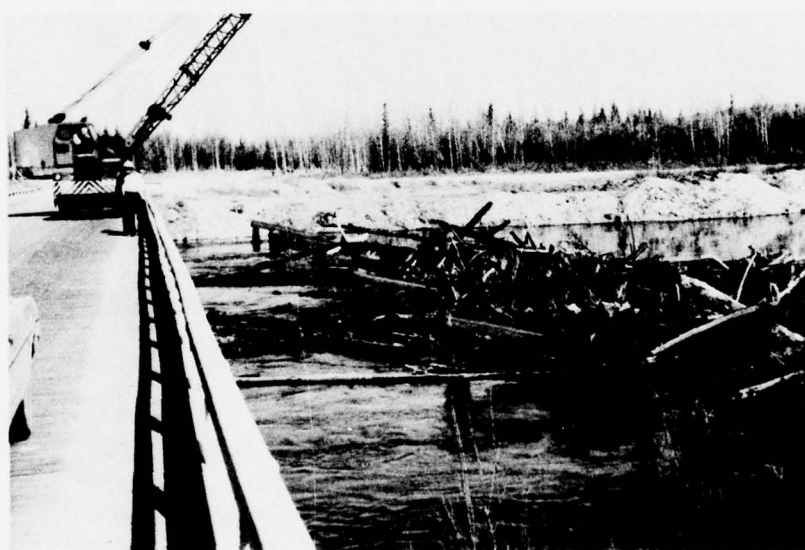
Figure 5. Debris accumulation on trash racks at Engineer Bridge, Fort Wainwright (12 May 1975). Note that debris did not accumulate against the bridge pilings.

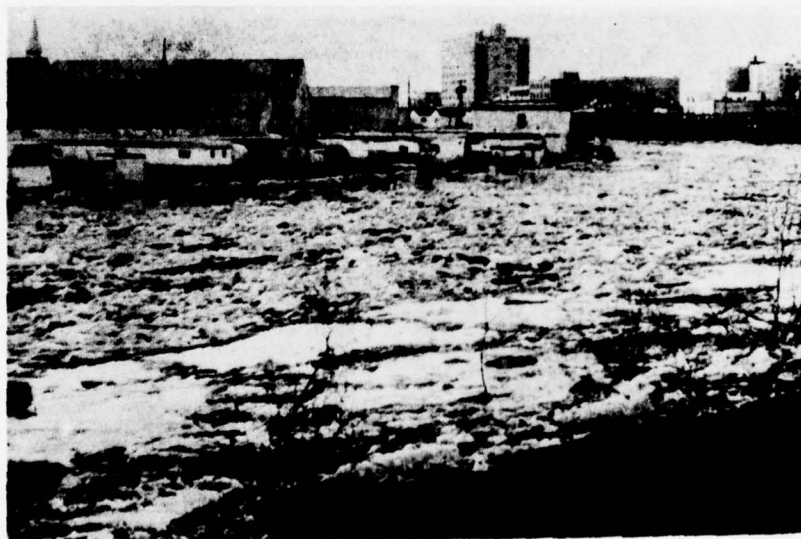
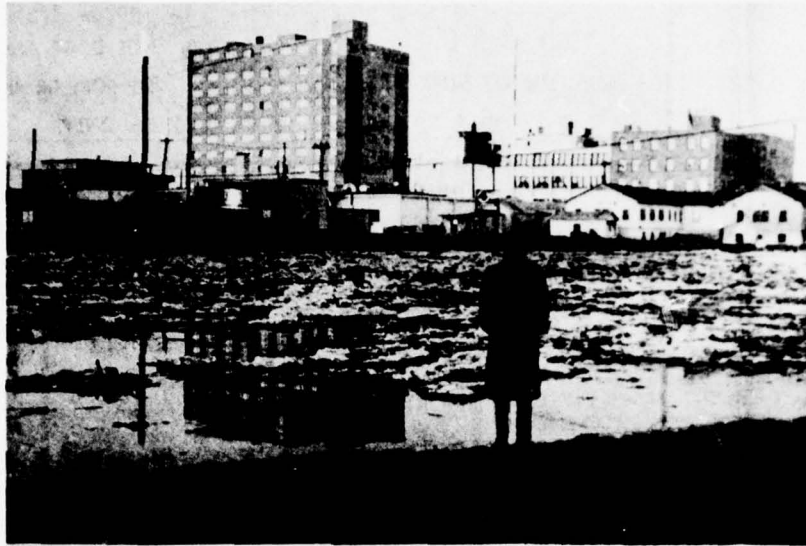
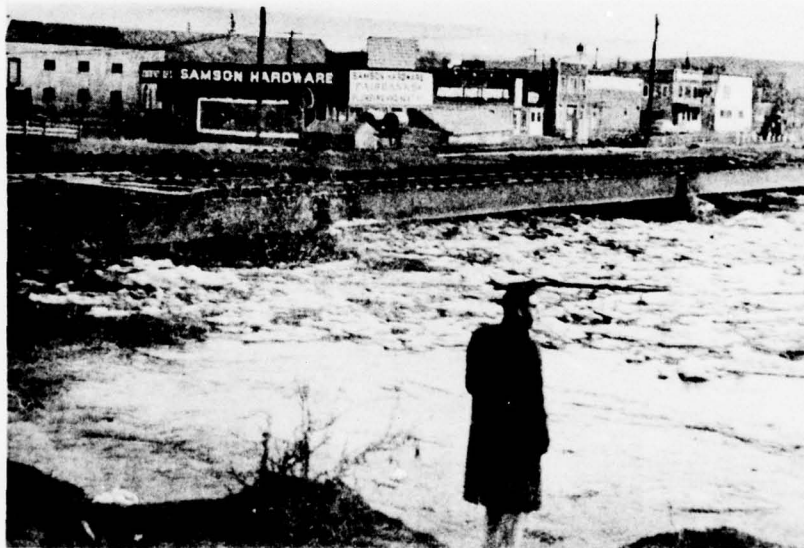
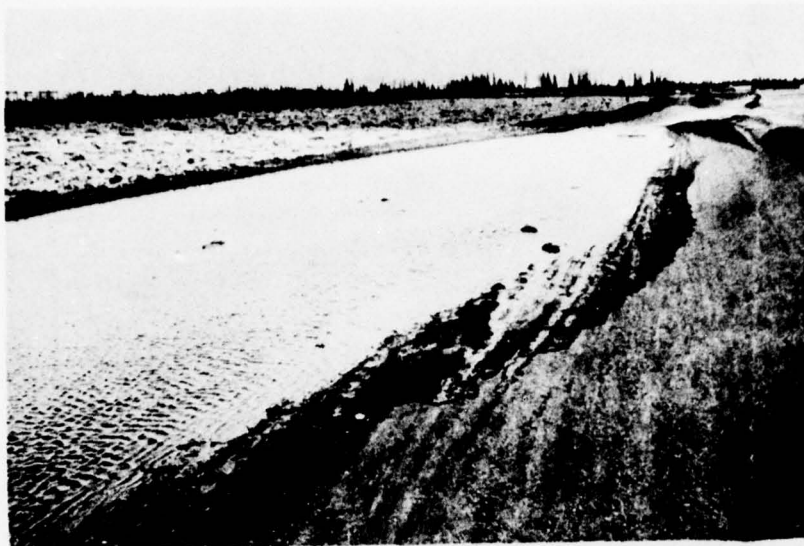
In 1960 high water and ice jams caused minor flooding at Fort Wainwright and in low-lying areas of Fairbanks. The river peaked above flood stage on 3 May at 19,900 ft³/s. Twelve Mile Village was flooded from the Tanana River and was declared a disaster area. Many parts of the Richardson Highway were under water. Figures 6-9 show parts of downtown Fairbanks and Fort Wainwright.

Figure 6. Ice and high water in downtown Fairbanks, 3 May 1960 (from Fairbanks News Miner).

Figure 7. Ice and high water in downtown Fairbanks, 3 May 1960 (from Fairbanks News Miner).

Figure 8. Cushman Street Bridge, 3 May 1960 (from Fairbanks News Miner).

Figure 9. Water over road at eastern end of Ladd AFB runway, 3 May 1960 (from Fairbanks News Miner).

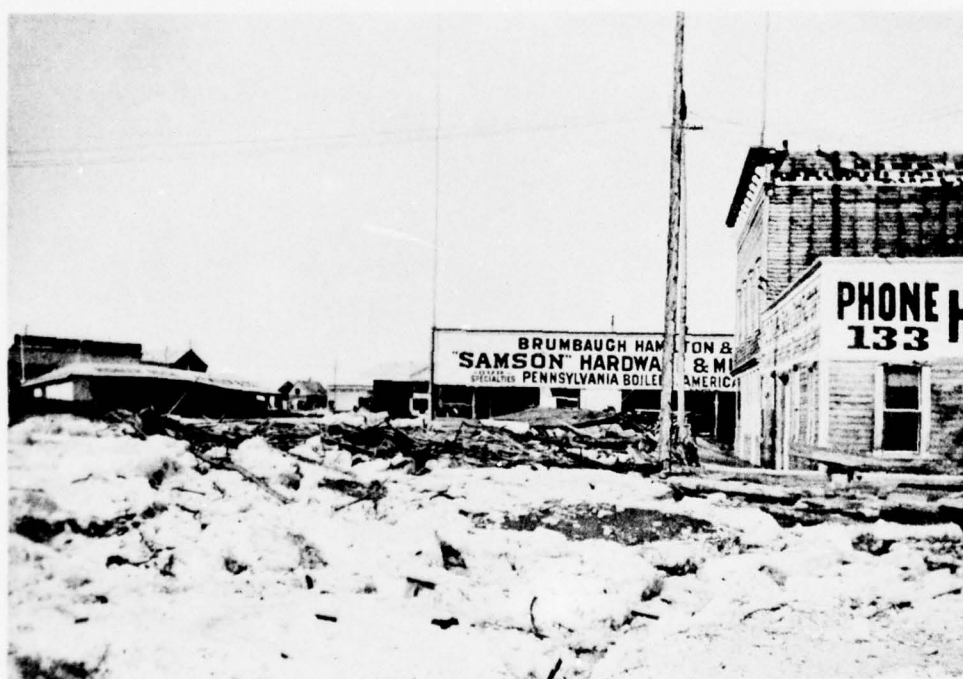
Figure 10. Fairbanks business area after breakup, circa 1915 (University of Alaska Archives, Charles Bunnell Collection).

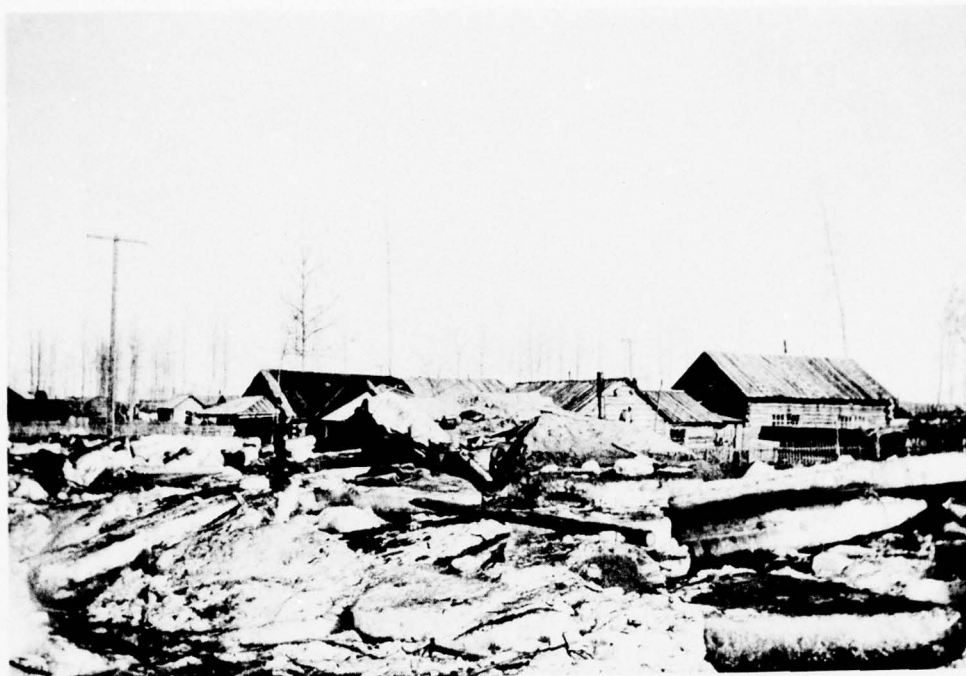
Figure 11. Grounded ice left by early day breakup, circa 1915 (University of Alaska Archives, Charles Bunnell Collection).

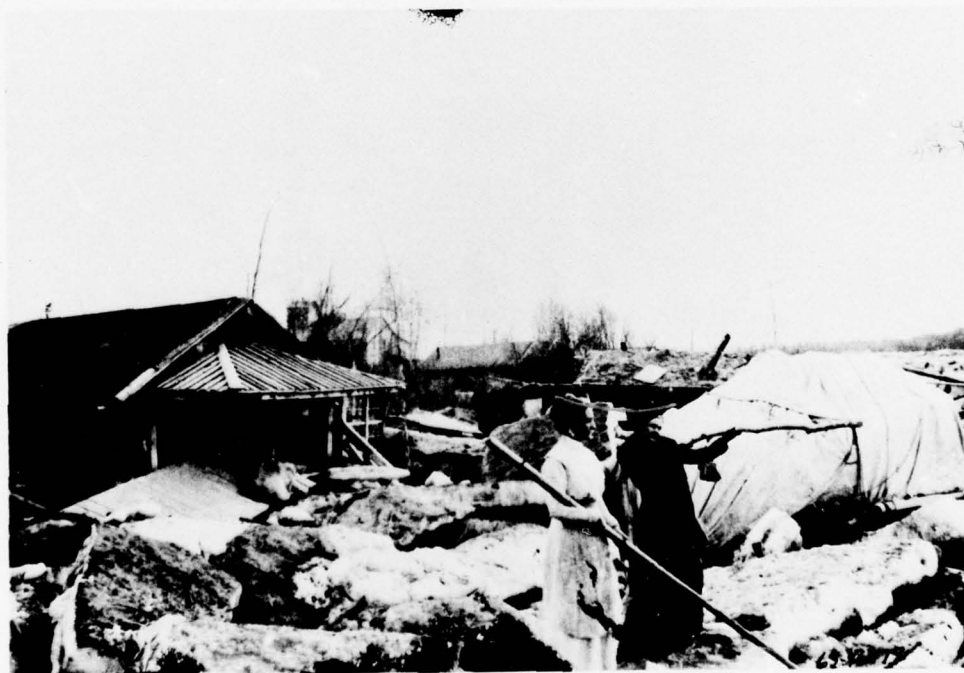
Figure 12. Ice damage from an early breakup, circa 1915 (University of Alaska Archives, Charles Bunnell Collection).

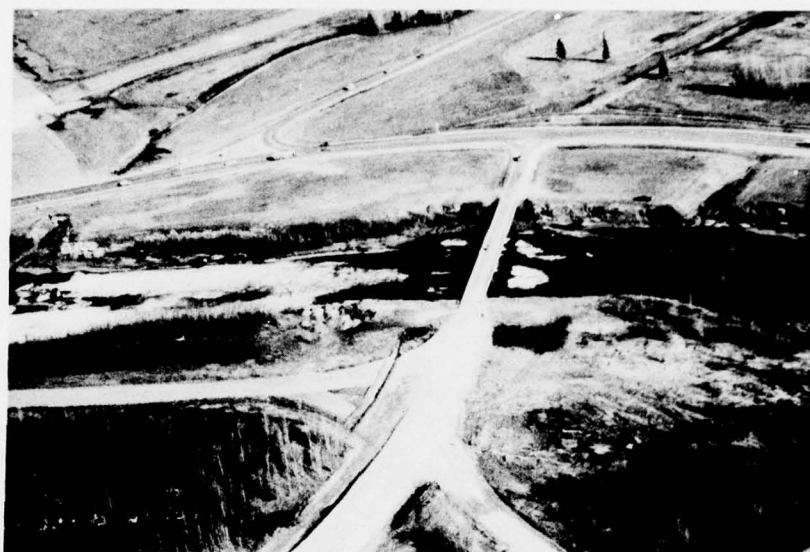
Figure A3. Checkpoint 3, 1 May 1975.

shaded area under the bridge still contained ice. By 1 May, further deterioration of the ice was noted (Fig. A3). The stage of the river had just started to rise slightly. Up to this time a sand bar below the bridge was evident, although it was a bit smaller on this date. The amount of ice below the bridge had decreased and the open water area above the bridge was considerably larger. A few small ice floes were noticed approximately 150 m upstream from the bridge as they jammed against the winter ice that had not yet moved out of this area. By 3 May, all the ice for 200 m upstream of the bridge had moved out. A few pieces of floating ice were jammed up on the trash racks. The river had continued to rise and the sand bar was almost covered. By the 5th (Fig. A4), the sand bar was completely covered as the river continued to rise. Several pieces of ice were jammed in front of the bridge on the trash racks. Two of these pieces appeared to be over 30 m long and approximately 10 to 15 m wide. No water was backed up by the ice and the jam was not causing any flooding. On 7 May the river was free of ice from its mouth to well above the bridge.

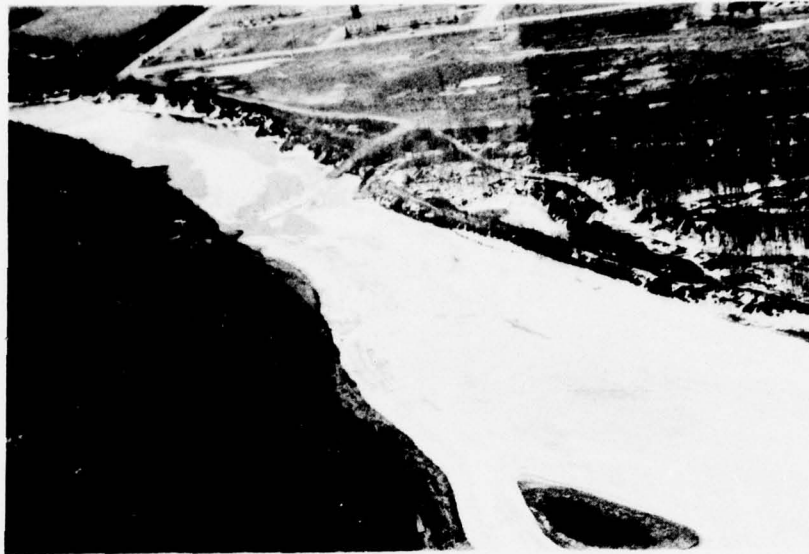
Figure A7. Checkpoint 4, 3 May 1975.

probably was not safe for traffic. By 3 May, the bridge was practically gone (Fig. A7). A little ice in its center area was noted; however, open water was extensive both upstream and downstream. By 5 May (Fig. A8), ice had completely moved out of the area of the bridge, jamming up 150 to 200 m downstream. It is interesting to note that extra thickness of ice at the bridge did not significantly prolong its usable life, nor did it cause any jams to form at that point. Instead, it broke up much the same as the rest of the river.

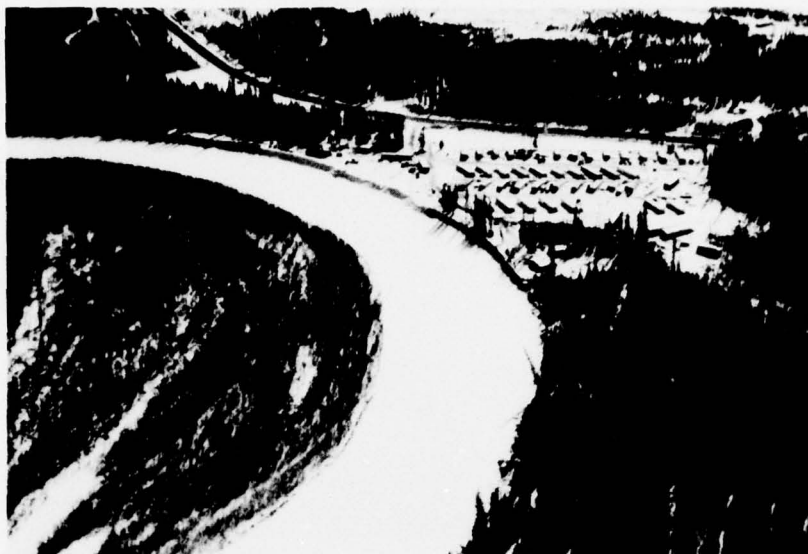
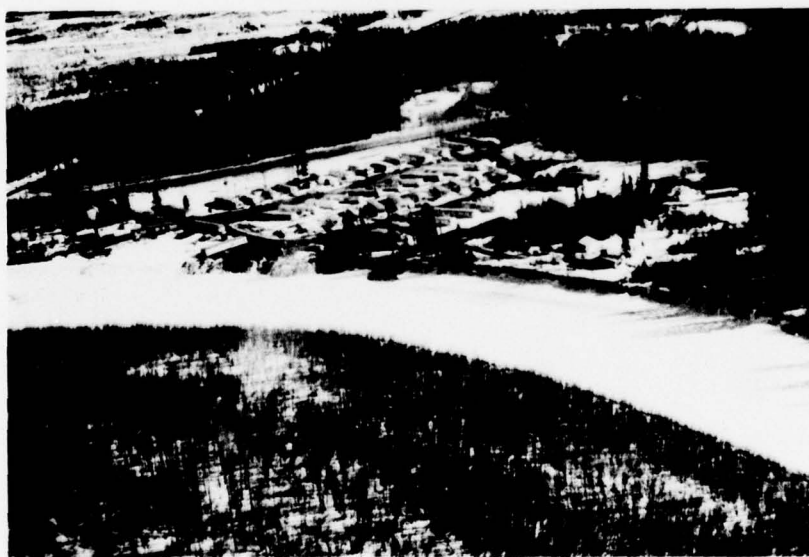
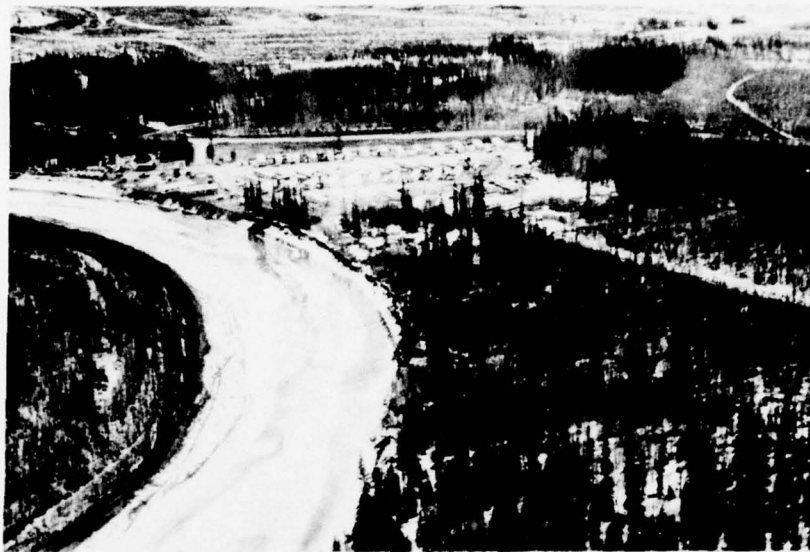
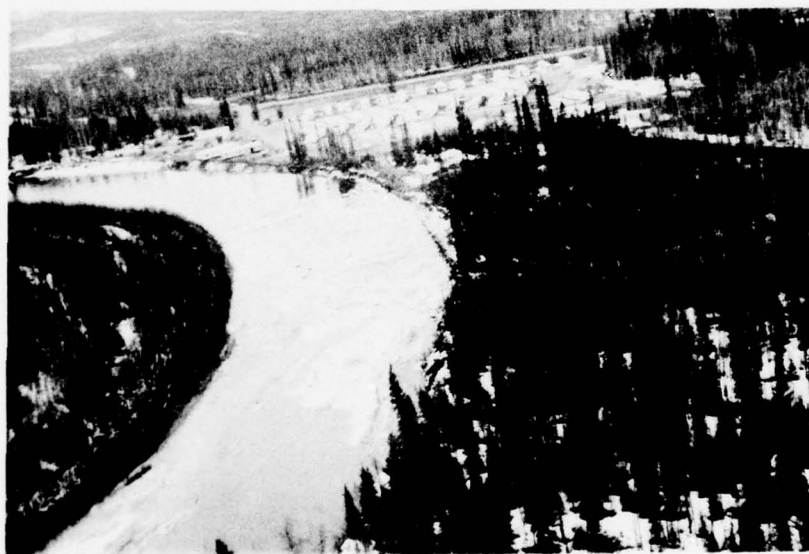
Checkpoint 6 was approximately 3.2 km (2 miles) upstream from the Golf Course Bridge, and is directly adjacent to the Badger Road Trailer Court (Fig. A13-A16). This checkpoint, located on a large sweeping bend, is typical of the lower river in general. The ice appeared to be completely intact at this checkpoint until 23 April. At this time, a dump of black material (ashes or gravel) was established on the ice near the trailer court site (Fig. A14). Immediately downstream of the dump, approximately 50 m, a very small area of wet ice about 25 m long and 5 m wide was noted. By the 24th, this area had increased in size noticeably, extending approximately 100 m downstream and starting within 5 m of the dump area, which had also increased in size (Fig. A14). Very little change occurred between the 24th and the 26th (as at the other checkpoints), primarily due to the colder weather. However, by 29 April the area of water on the ice had increased dramatically, extending 200 to 250 m downstream and covering at least half the channel portion of the river. Open water was evident in the area immediately downstream of the dump. On this date some open water also began to appear upstream of this area. By 3 May, the area around the dump was entirely open. On 5 May, the ice moved from the area, forming a moderate sized jam immediately downstream of this checkpoint (Fig. A16). The jammed area was approximately 200 m in length, covering the entire width of the river and containing many small pieces of floating ice that had come from upstream. By

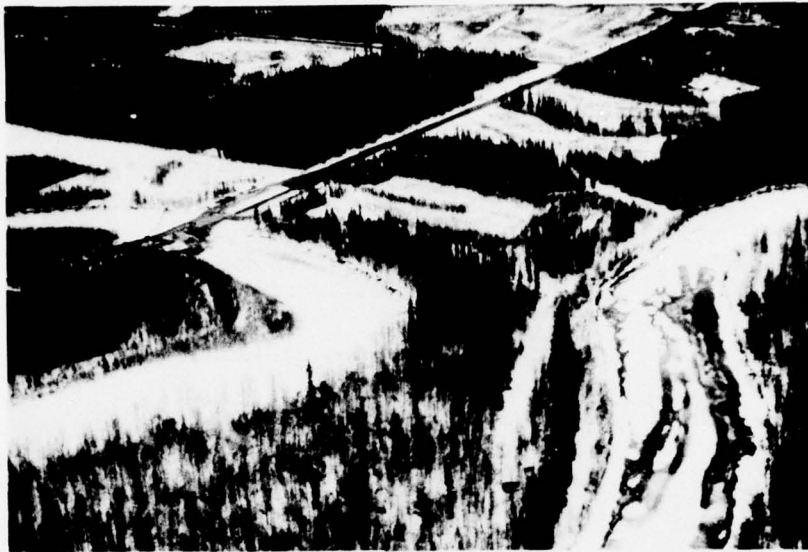
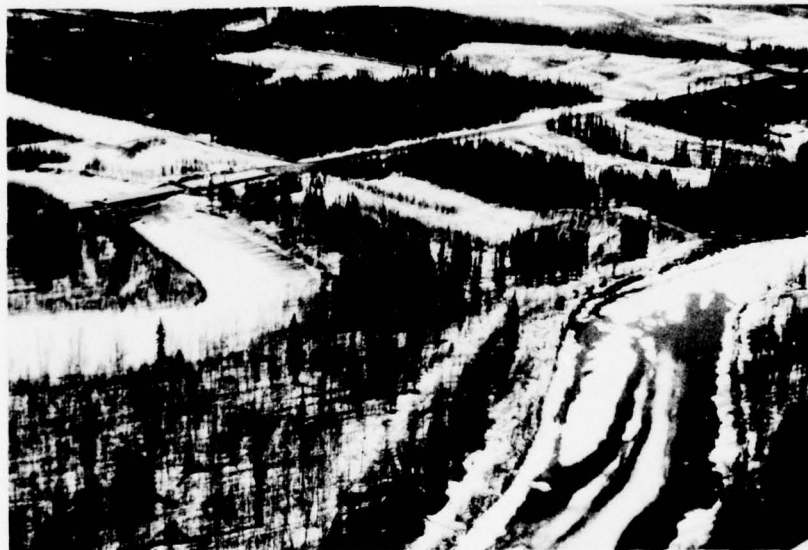
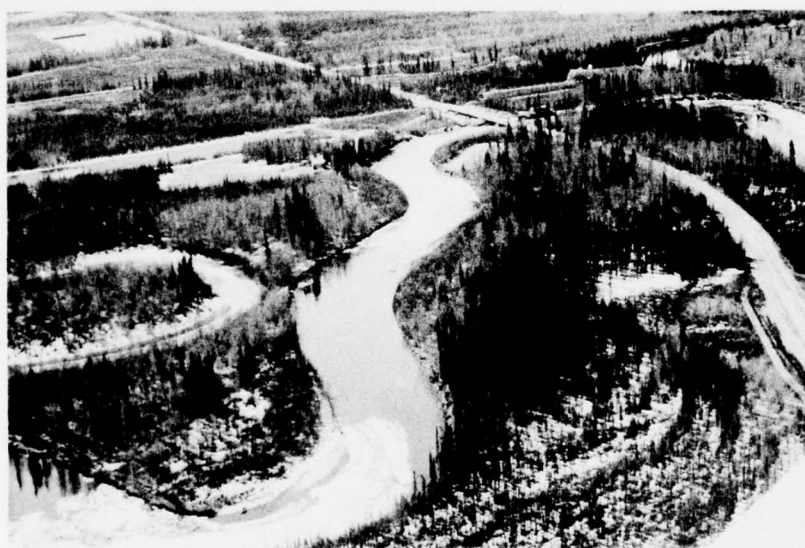
Checkpoint A was near a new bridge under construction on Nordale Road (Fig. A17-A20), approximately 8 km (5 miles) upstream from the Badger Road Trailer Court. Little difference in the method of ice breakup was noted in this checkpoint as compared to the other bridges, with the exception that the ice remained in this area of the river longer and was the last on the river (along with the ice at checkpoint 7) to move out. On 7 May there were still several jams between this checkpoint and the next.

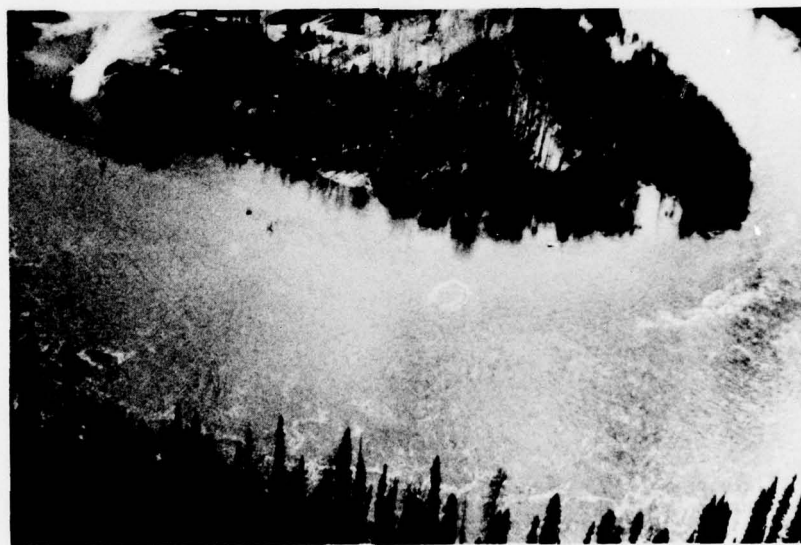
Figure A40. Checkpoint 10, 12 May 1975.

Above the damsite, minor flooding was observed along the river for several miles. At the Chena Park campground, a car parked on what is normally a dry gravel bar beside the river was submerged with only its roof remaining above water (Fig. A40).
